Manhole Inspection Summary

Manhole # S41A__018MH

Insp Date: **7/18/08 9:12 AM**

Location Address: **528 mcelderry st**

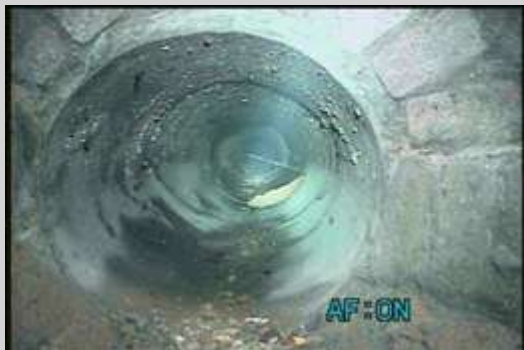
12 O'Clock Outflow

10 in. Circular Gravity Sewer
Pipe Out @ 12 O'Clock

Pipe Material: **Clay** ☐ Pipe Lined

Invert Depth: **7.57** (ft.) Flow Characteristics: **None**

Deposits: ☒ None ☐ Mud ☐ Sludge ☐ Debris ☐ Grease

Infiltration: **None**

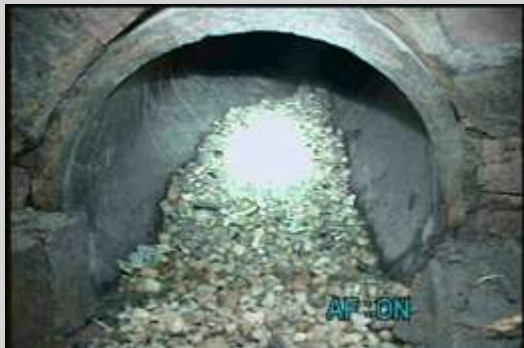
5 O'Clock Inflow

10 in. Circular Gravity Sewer
Pipe In @ 5 O'Clock

Pipe Material: **Clay** ☐ Pipe Lined

Invert Depth: **7.28** (ft.) Flow Characteristics: **None**

Deposits: ☒ None ☐ Mud ☐ Sludge ☐ Debris ☐ Grease

Infiltration: **None**

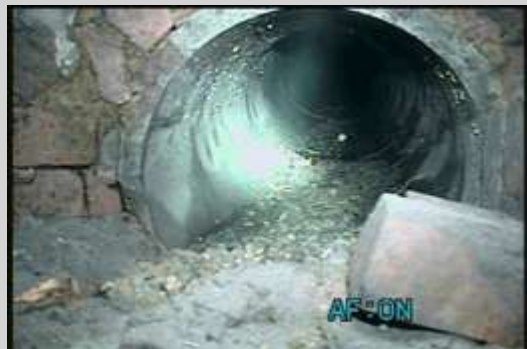
6 O'Clock Inflow

10 in. Circular Gravity Sewer
Pipe In @ 6 O'Clock

Pipe Material: **Clay** ☐ Pipe Lined

Infiltration: **None**
